STUDY #1 IN A SERIES OF REPORTS ON RADON IN BC HOMES

## A Comparison of Three Radon Systems in British Columbia Homes:

**CONCLUSIONS AND RECOMMENDATIONS FOR THE BRITISH COLUMBIA BUILDING CODE**

**OCTOBER 2014**

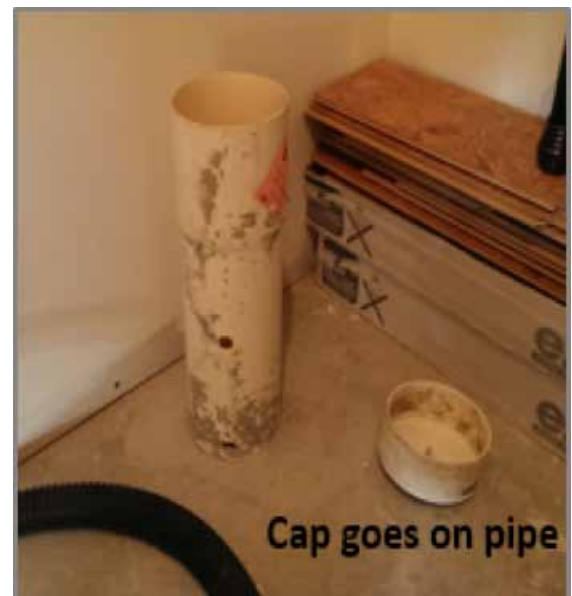
While this home was identified as meeting the year of construction criteria it clearly was not compliant with the 2012 Code in several ways:

- The rough-in pipe had not been capped by the home builder and simply left on the floor, and this situation was not observed during final inspection by the Code compliance authority.
- The radon pipe was perforated. Even if the cap had been placed the perforations in the pipe allowed radon entry into the home.
- The cost of fixing this issue and then making extensive internal alterations to install a passive pipe system through finished space to the roof would have been prohibitive.

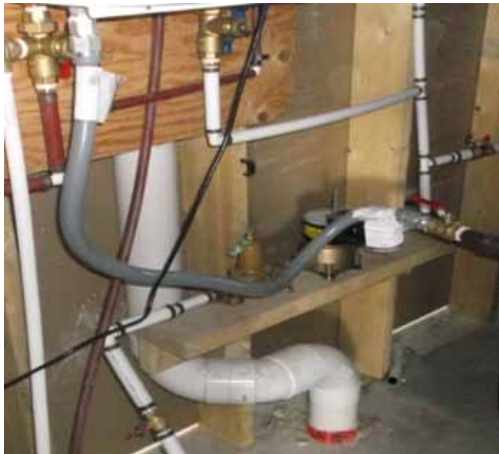
In 15 of 16 homes the radon pipe was not clearly labelled (Figure 1).

**Issue** - Residents may not identify the radon pipe's function. This could lead to improper use.

Figure 1. Example of Pipe Not Labeled

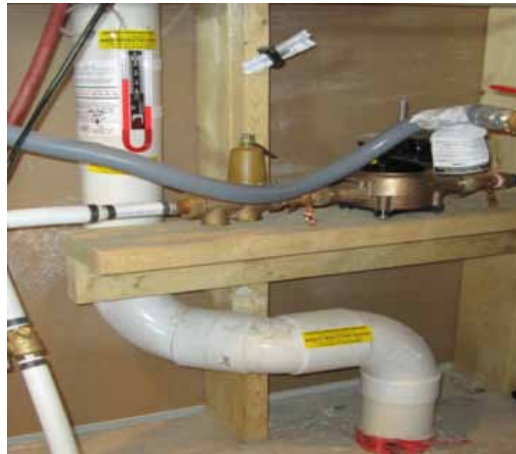
Figure 2. Example of Pipe Labeled

**Solution** - Apply a Radon Pipe Warning label (Figure 2).

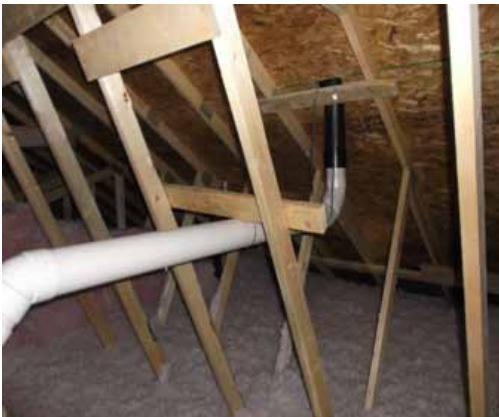
In all homes the radon pipe was not insulated in unconditioned spaces (Figure 3).

**Issue** - System may not work to maximum efficiency if pipe is not insulated in an unconditioned space and condensation may form in the pipe.

Figure 3. Example of Uninsulated Pipe

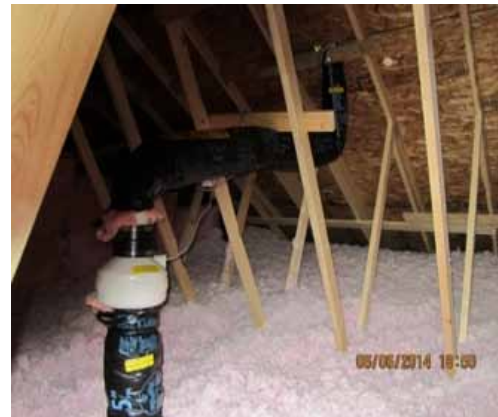
Figure 4. Example of Insulated Pipe

**Solution** - Insulate the radon pipe all the way through to the roof (Figure 4).

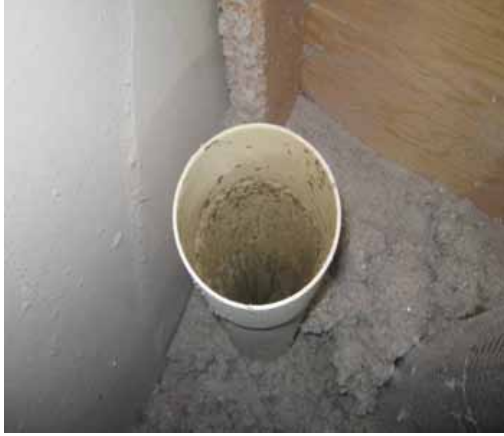
In 2 of 16 homes the radon pipe was venting into the attic (Figure 5).

**Issue** - Radon venting into attic increases risk of radon levels in living space, condensation may form on the pipe and affect insulation and water on ceiling, and mold may establish in attic space.

Figure 5. Example of Pipe Venting Into Attic

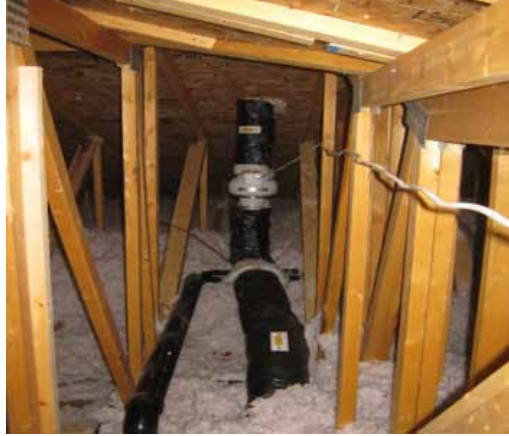
Figure 6. Example of Pipe Venting Out Roof

**Solution** - Ensure radon pipe is vented out the roof (Figure 6).

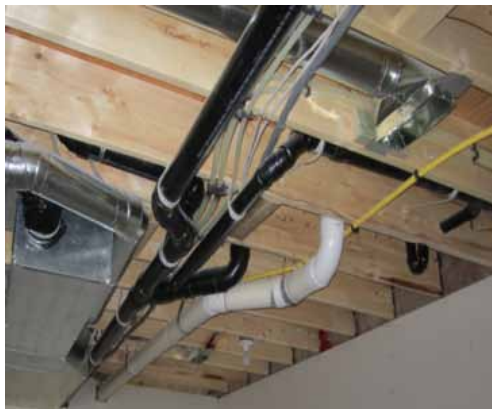
Figure 8. Example of Pipe Run Supported with Bracing

**Solution** - Provide adequate bracing along the horizontal runs of pipe (Figure 8).

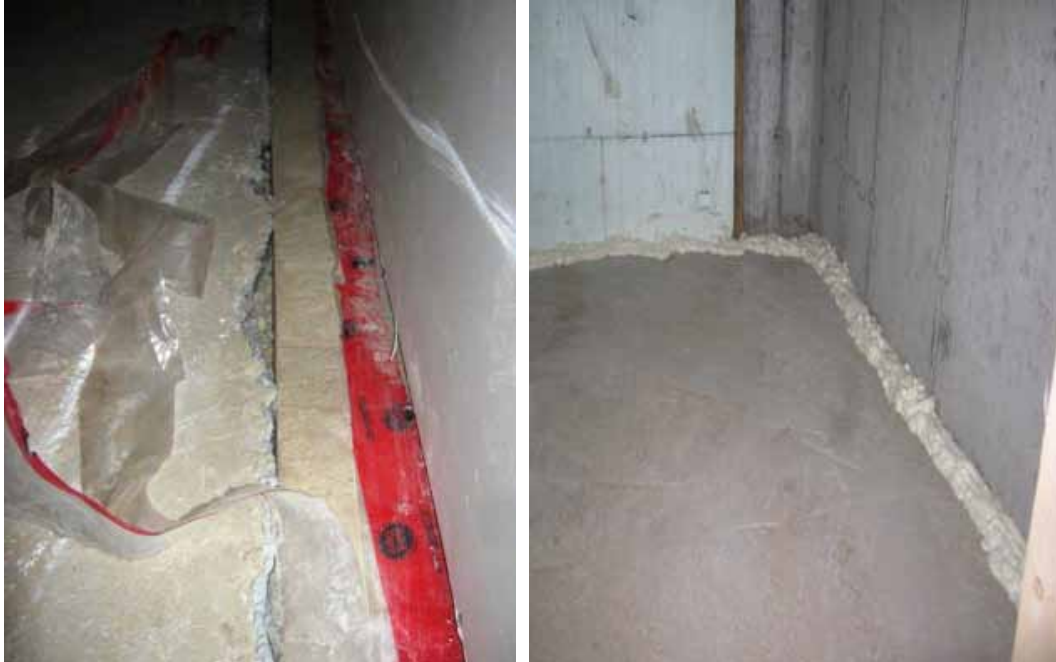
More than half of homes had inadequate sealing in the slab-floor and edges (Figure 9).

**Issue** - Slab floor cracks, rough edges, and open gaps can be a point of radon ingress.

Figure 9. Example of Inadequate Sealing of Slab Edges Figure 10. Example of Slab Edges Sealed with Spray Foam

**Solution** - Ensure proper sealing of all edges, cracks and openings in slab floor (Figure 10).

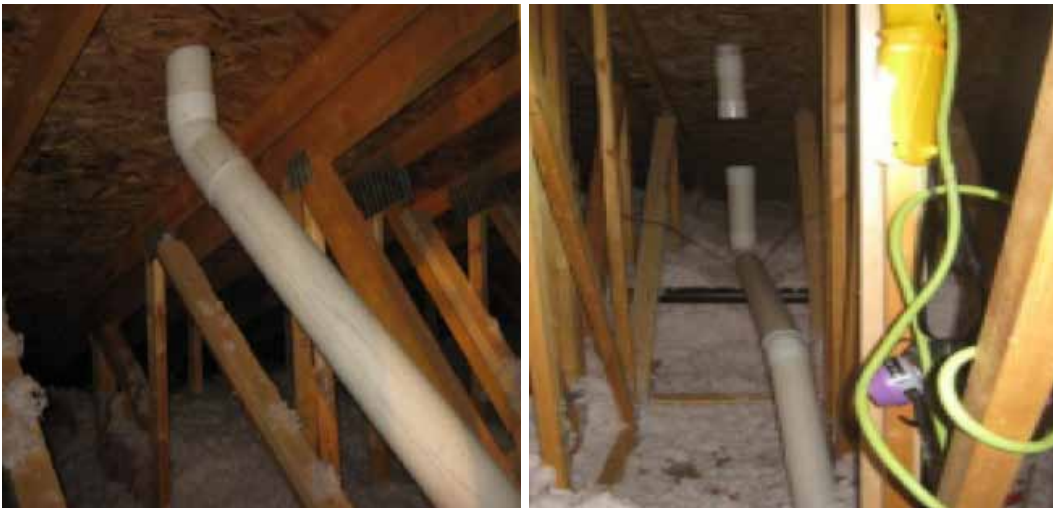
In 2 of 16 homes the radon pipe was positioned in the attic on an angle (Figure 11).

**Issue** - A radon fan installed to a radon pipe on an angle may get moisture pooling in the fan casing. This will impact the efficacy of the radon fan.

Figure 11. Example of Radon Pipe Positioned on Angle Figure 12. Example of Radon Pipe Cut and Straightened

**Solution** - Ensure that the radon pipe exiting the attic is completely vertical (Figure 12).

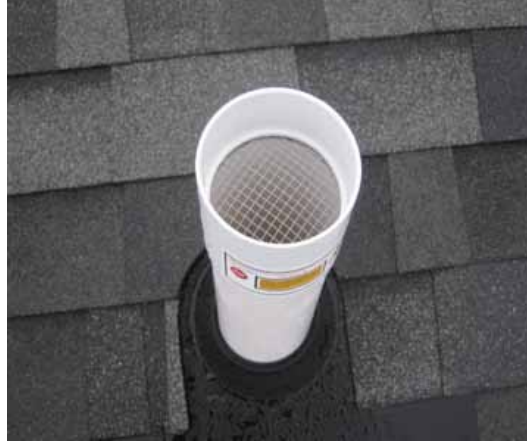
In all 16 homes the radon pipe exiting the roof was unscreened (Figure 13).

**Issue** - Debris may fall into the pipe and block the flow.

Figure 13. Example of Radon Pipe End with No Screen      Figure 14. Example of Radon Pipe End with Screen

**Solution** - Insert a screen onto the end point of the radon pipe (Figure 14).

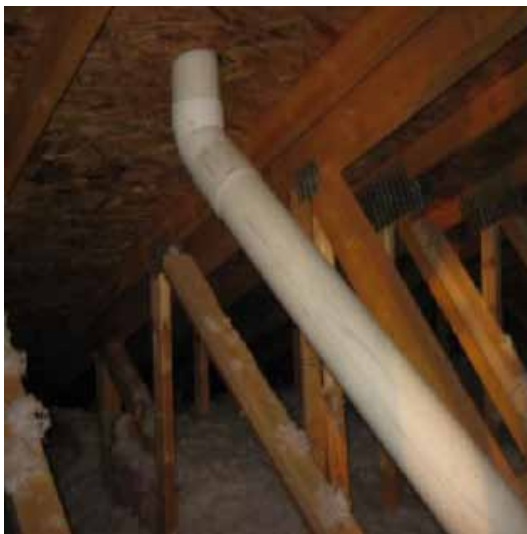
More than half of homes required installation of electrical provisions near the radon pipe in the attic (Figure 15).

**Issue** - Installing an added electrical connection in the attic at the same time as a Passive System install can substantially reduce costs for future application of an Active Radon Reduction System.

Figure 15. Example of Passive Pipe with No Electrical Provisions

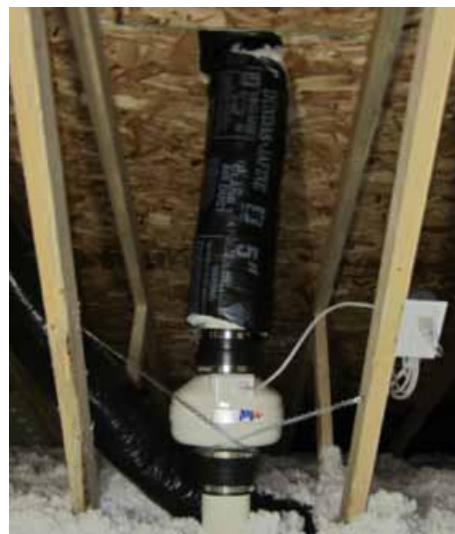
Figure 16. Example of Pipe with Electrical Provisions Added

**Solution** - Install an electrical connection during Passive System install (Figure 16).
