RADON AWARE CASE STUDY #1  
IN A SERIES OF REPORTS ON RADON IN BC HOMES

# A MODEL FOR RADON TESTING AND MITIGATION IN AFFORDABLE HOUSING

JUNE 2016

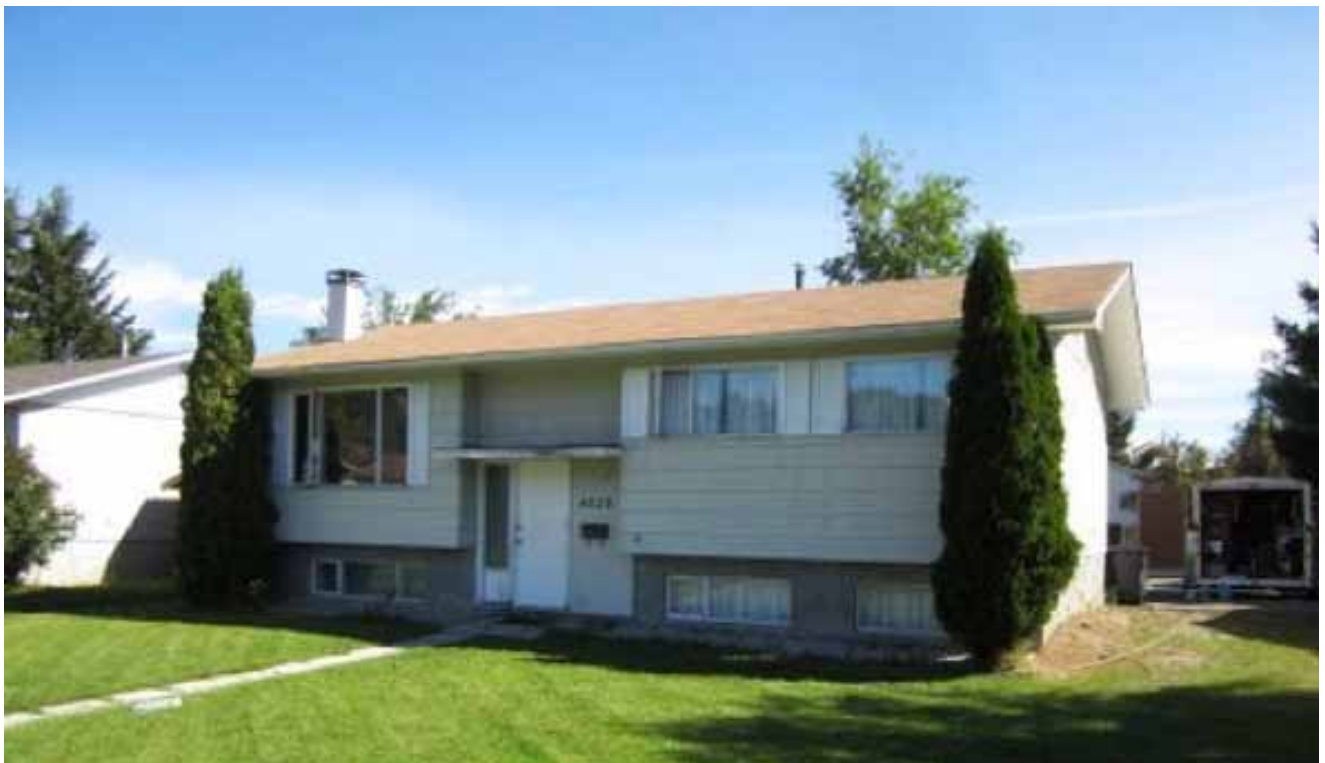
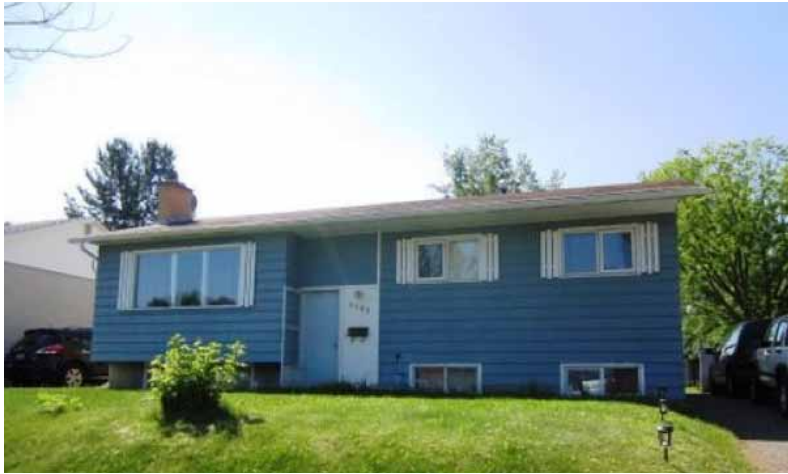
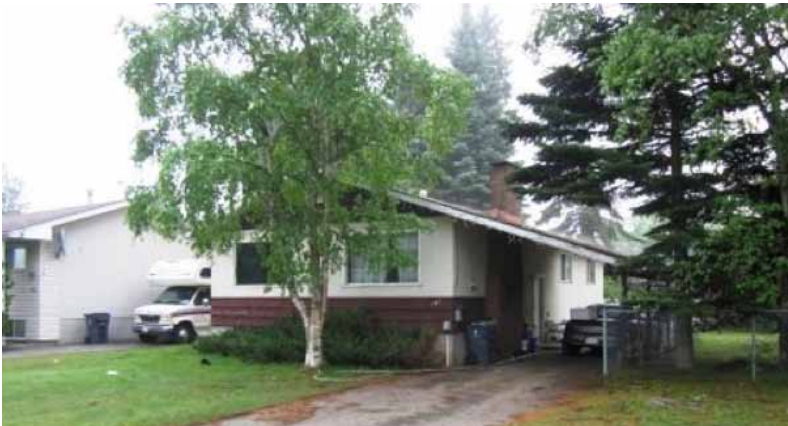
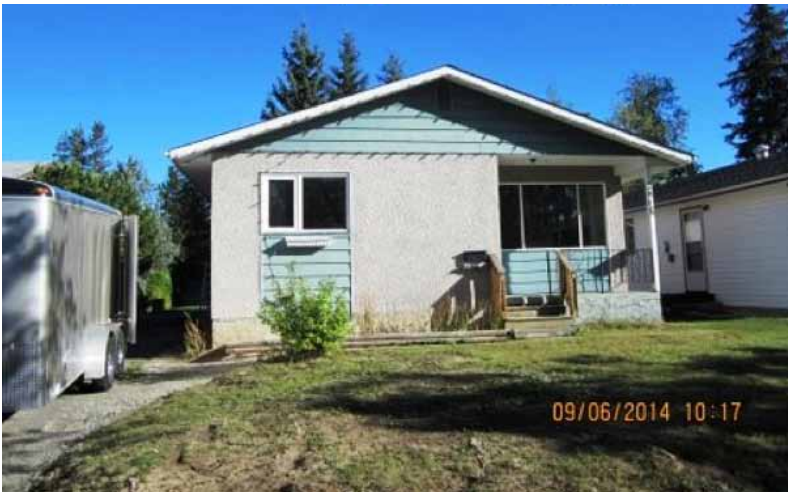
All of the 136 AHSPG houses in the study are located within the City of PG. Most of the houses are single family detached dwellings with full basements as shown in Figures 1, 2, 3 and 4. The average age of house in the study was 49 years, with most houses constructed in the 1970s. Most of the people and families living in the houses are considered long-term tenants. In other words, these houses are truly 'home' to many people.

Figure 1. AHSPG House with Basement

Figure 2. AHSPG House with Basement

Figure 3. AHSPG House with Basement

Figure 4. AHSPG House with Basement

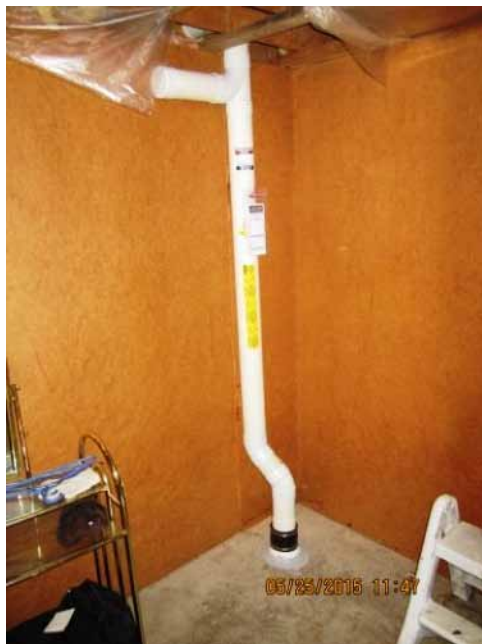
An ASDS reduces the amount of radon entering a home by enabling its evacuation from below the sub-slab via a pipe. This pipe typically extends from the sub-slab (Figure 5), and out the roof, or via a side-wall as shown in Figure 6. Attached to the pipe is an electrically powered fan (as seen in Figure 6) that helps to increase the draw of soil gases from below the foundation and out the pipe.

**Figure 5.** Radon Vent Pipe through Sub-slab

All 36 houses that tested at or above the Health Canada guideline of 200 Bq/m<sup>3</sup> received an ASDS.

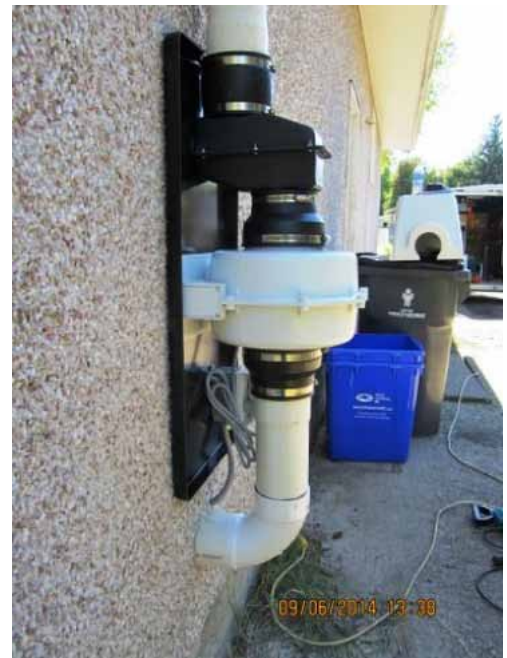
**Figure 6.** Radon Pipe Venting through Side Wall
